**Replacing a Threaded Rod and/or Stop Block contained in the Channel of the BAL Retract-A-Spare tire carrier.**  
**This guide will also help with cable replacements and general disassembly.**

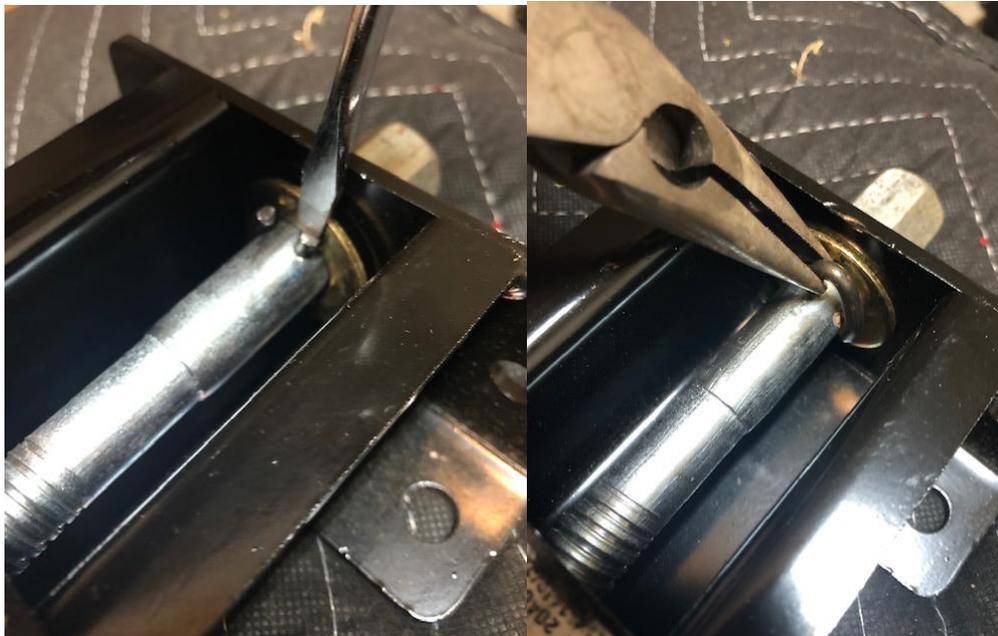
1. Using a 3/4" wrench or socket, release about 12 inches of cable from the carrier by turning the nut counterclockwise.
2. Remove the retaining pin from the threaded rod using a punch or small nail. Tap lightly on the pin until it is about halfway out then rotate the threaded rod 180 degrees to finish removing the pin with a pair of pliers or vice grips.

8. Reinsert the threaded rod into the carrier making sure one washer is on the drive nut side of carrier and the other is on the interior of the carrier. Refer to Step 2 photo for reference.
9. Carefully thread the rod clockwise into the threaded block BY HAND. Once you feel the rod catch the threads in the block, continue to HAND CRANK five revolutions to make sure the block is not cross threaded. Once you are sure that it is safely threaded together, use a 3/4" wrench or socket to continue to crank the rod into the block.
10. Attach the cable to the stop block as shown in the photo in Step 5 and 6 and reinsert into the channel opening. Slide the block towards the drive end of the channel until the holes in the channel line up with the hole in the stop block. Reinsert the 3/8" bolt and nut using 9/16" wrenches or sockets.

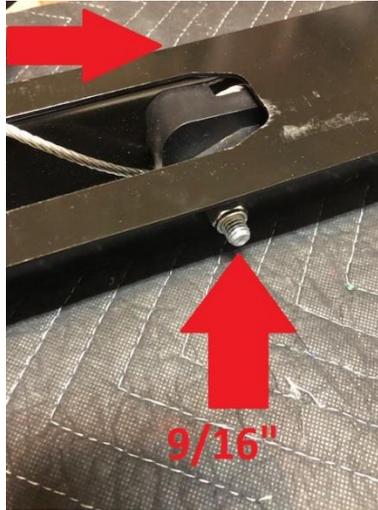
4. Using two 9/16" wrenches or sockets, remove the bolt holding the plastic stop block from the carrier by sliding it out of the channel opening. Please note the routing of the cable on the stop block for reference during reassembly.

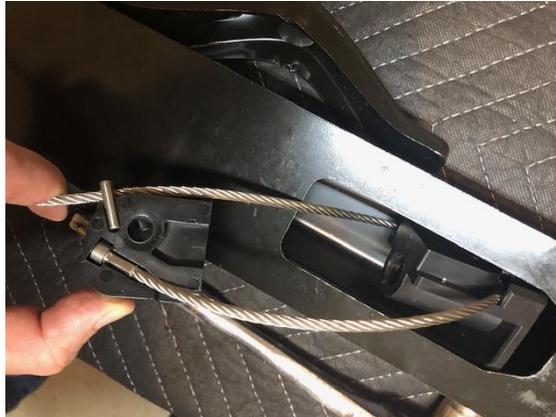
5. Using the cable, pull the threaded block towards the channel opening until it can be removed from the channel. If the threaded block is intact, note the routing of the cable on both blocks for reference during reassembly. Remove the cable & discard the block if damaged.

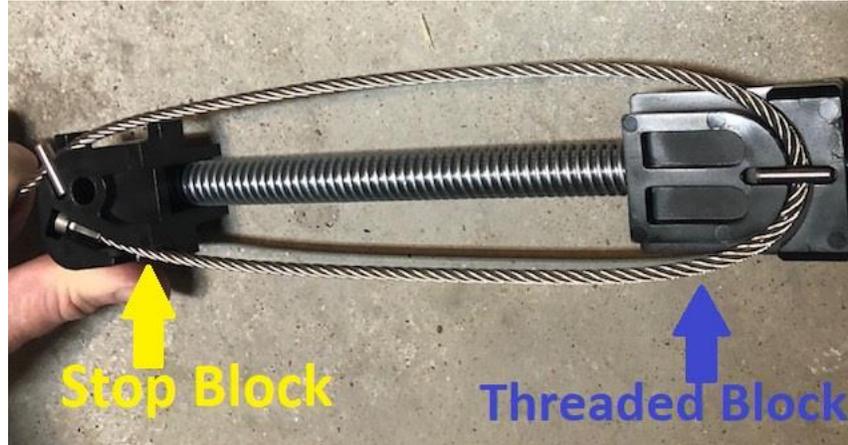
6. Using the new threaded block and the stop block, replace the cable by routing it as noted in steps above. Use the image below as a reference. The cable reinstalls against the channel wall and NOT pointing 'up'.

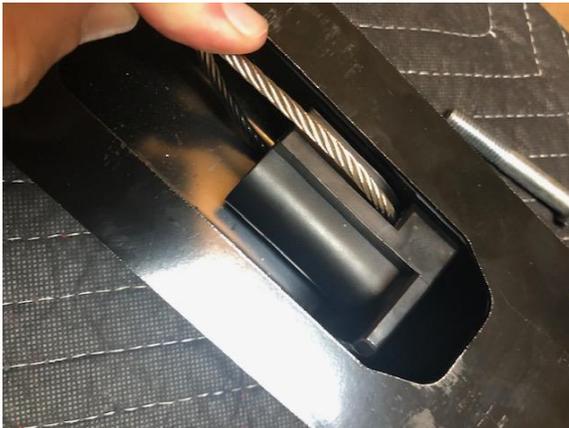
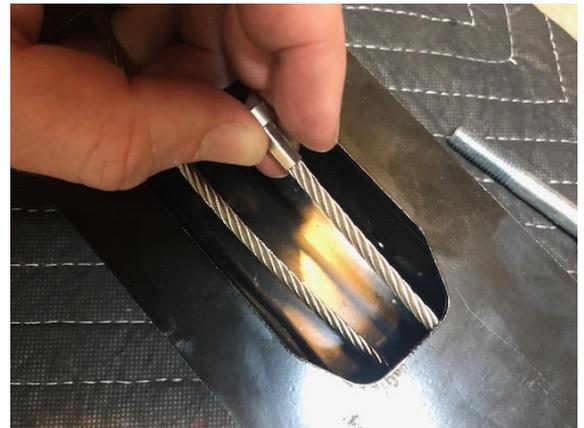
7. Place the threaded block with cable attached into the channel opening and slide it towards the drive end of the channel. Push the threaded block as far down the channel as possible keeping the cable in the correct routing location. Be sure to hold onto the end of the cable and not let it slip into the channel where it cannot be reached.
